CLEARONE DOCUMENT NTS-0042-001
(REVISION 1.0) May 2016

BEAMFORMING MICROPHONE ARRAY COMMUNICATION ERROR SOLUTIONS AND REVISED INSTALLATION REQUIREMENTS

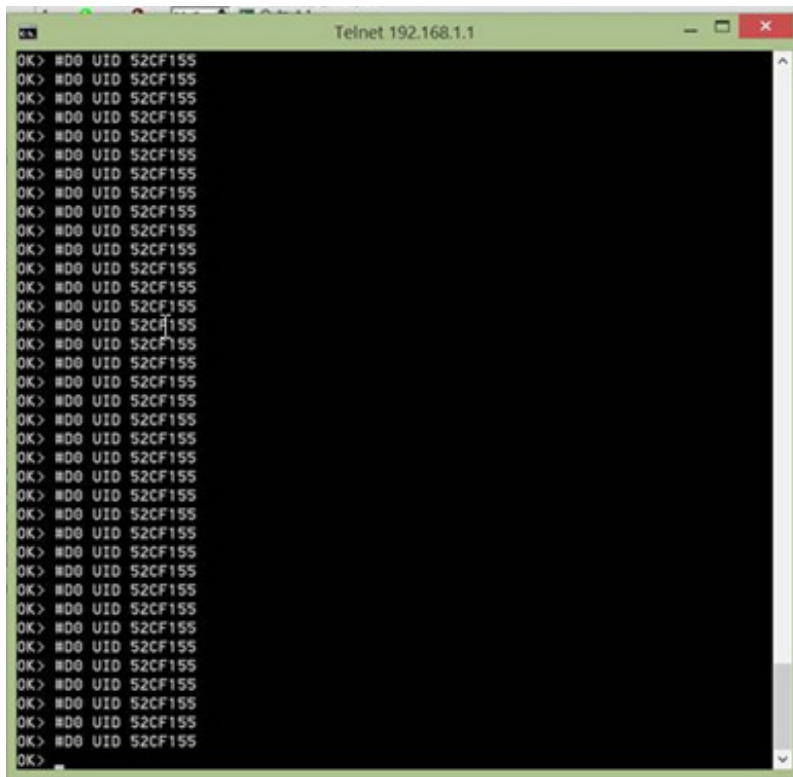
Other instances of communication failures are associated with repeated Ebus device discovery events that can be seen as a repeated broadcast of UID strings. Establish a telnet connection to a Proxy DSP and observe the connection for a few minutes. See below for an example of a BMA attached system with Ebus issues:

This cause of this failure was determined to be a Cat 6 cable terminated with Cat 5 connectors connected between the BMA and the CONVERGE Pro DSP.

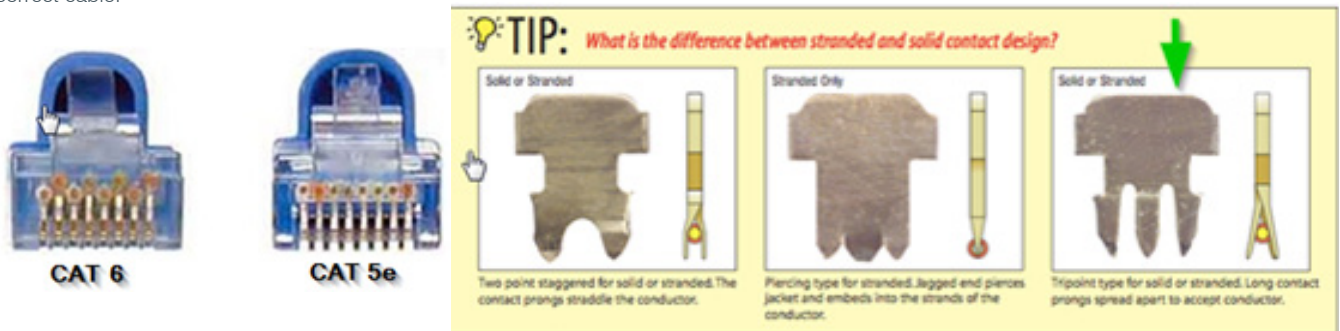
CAT 6 (Left) and CAT 5 (Right) connectors are Use connectors made for solid core cable. The contact design on the right is preferred. different! Use the correct connector with the correct cable.

There are two types of modular plugs!

Connectors are important; installers must certify they are using the correct specification and type for solid core Cat 6 when using Cat 6 cable:

Shielded cable types must be terminated with shielded connectors and ground wires must be connected properly.

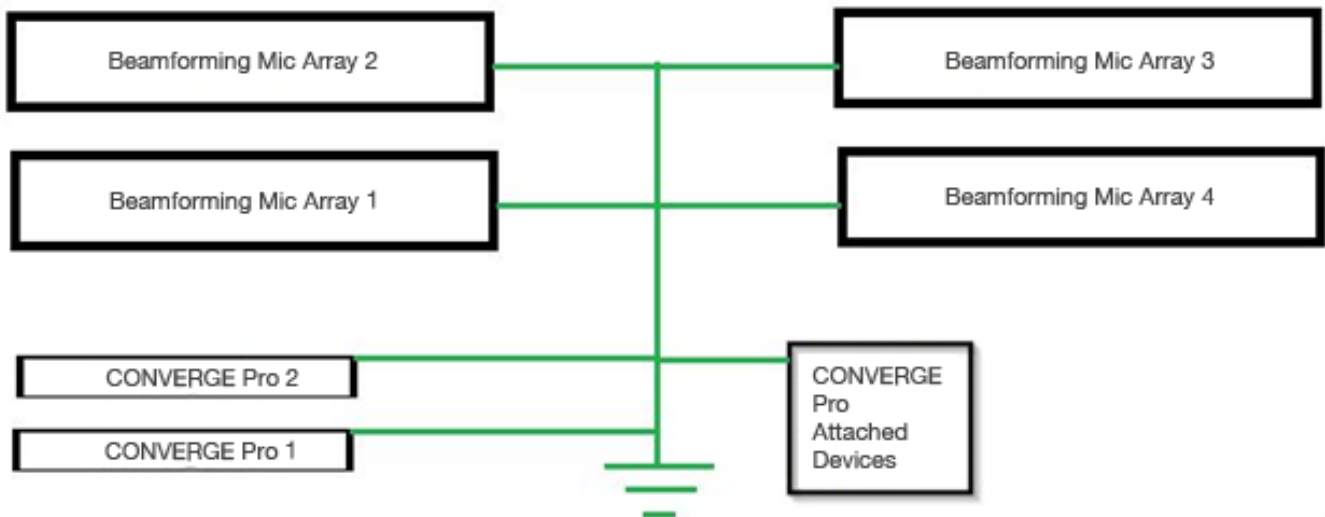
Large installations that have several rooms spread out over a large area often result in different AC circuits being used to power the BMAs, DSPs and attached peripherals. It is very common for a voltage differential to arise between the ground wires of different AC circuits in commercial buildings. This can cause Ebus communication failures.

We have found through testing that as little as 1.8 V between AC ground on any device connected on the same Ebus network can result in Ebus communication failures. All CONVERGE Pros and BMA PoE Power injector supplies must share a common ground, even if devices are distributed across different rooms.

- All ClearOne devices connected to the same expansion bus network should be powered by the same AC circuit and a good quality AC ground should be common between all systems. An exclusive technical AC ground may be provided to all CONVERGE Pro equipment to avoid common line interference from attached non-AV equipment.
- PoE Power injector modules or third party PoE switch supplies and CONVERGE Pro DSPs will need to share the same technical AC ground.
- AC isolation transformers may be used when it is impossible to connect all ClearOne devices to the same AC circuit, or when ground issues are suspected.
- An electrician can certify power quality and correct ground issues that AV installers may not be able to overcome using the above recommendations.
