Updating Your XAP and PSR Products

This document will assist you in determining if XAP and PSR products need to be upgraded, how to install G-Ware, and how to perform a boot-code and firmware upgrade on a XAP 800, XAP 400, XAP TH2 and PSR1212. For detailed information about the enhancements included in a G-Ware or firmware release, please refer to the Release Notes (on the CD-ROM) or the *G-Ware Revision/Upgrade History* in Section 4 of this document. **For XAP-Net upgrade procedures, please refer to the XAP-Net manual.**

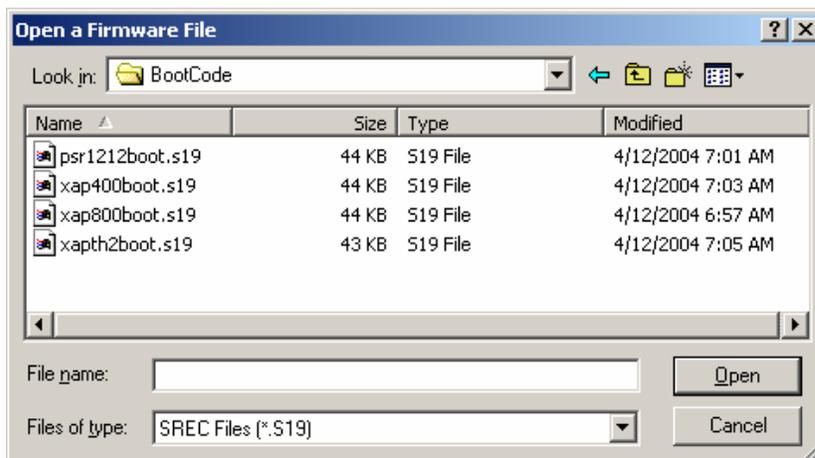
2. Click **Browse** to access a list of available firmware updates. Double-click the **Bootcode** folder to open it. Select the file that matches the type of unit you are upgrading and click **Open**.

- The selected boot-code file self verifies and displays the message **Verified, OK**. If the file information matches your unit and the file is verified, click **Next** to advance to the Communications tab.
- Select the PC **COM port** you are using for the upgrade. Confirm that the **Baud Rate** matches the baud rate of the selected unit.

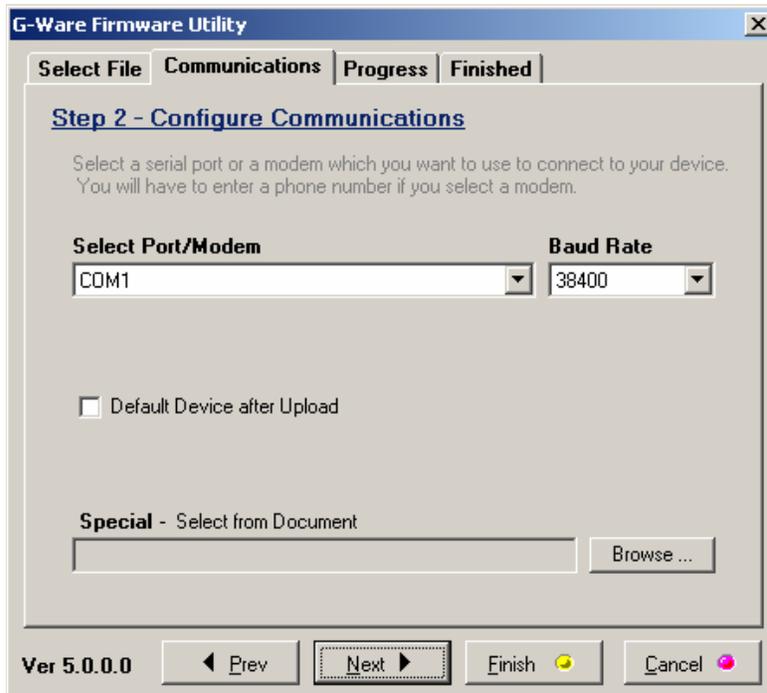
- Click **Next**. If the upgrade requires you to save your site files, a warning message displays. If you have not saved, you will need to exit the G-Ware Firmware utility, sync to the units with your current G-Ware version (see Technical Note #109: *G-Ware Switcher*), and save the site file(s). Click **Yes** to continue with the Boot-code upload.

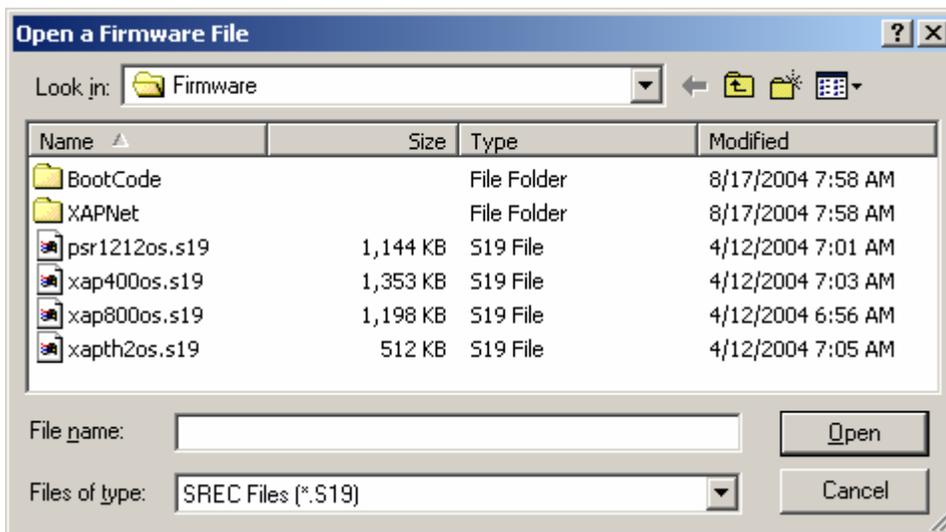
- Click **Browse** to access a list of available firmware updates. Select the file that matches the type of unit you are upgrading and click **Open**.

- The selected firmware file self verifies and displays the message **Verified, OK**. If the file information matches your unit and the file is verified, click **Next** to advance to the Communications tab.
- Select the PC **COM port** you are using for the upgrade. Confirm that the **Baud Rate** matches the baud rate of the selected unit.

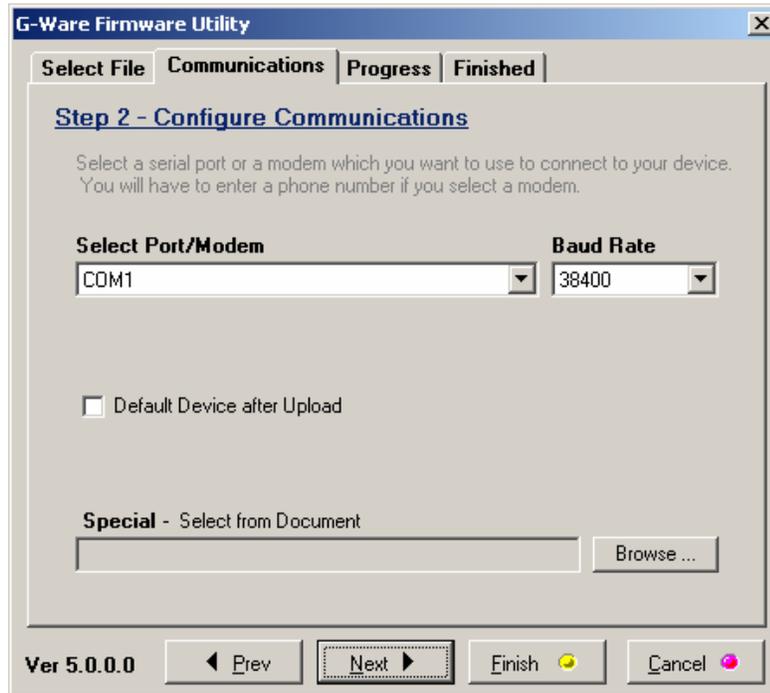
5. Click **Next**. If the upgrade requires you to save your site files, a warning message displays. If you have not saved, you will need to exit the G-Ware Firmware utility, sync to the units with your current G-Ware version (see G-Switcher Tech Note #109), and save the site file(s). Click **Yes** to continue with the firmware upload.
